BULGARIAN FIGHTER COLOURS 1919–1948

Vol. 1

Rainbow No 9136

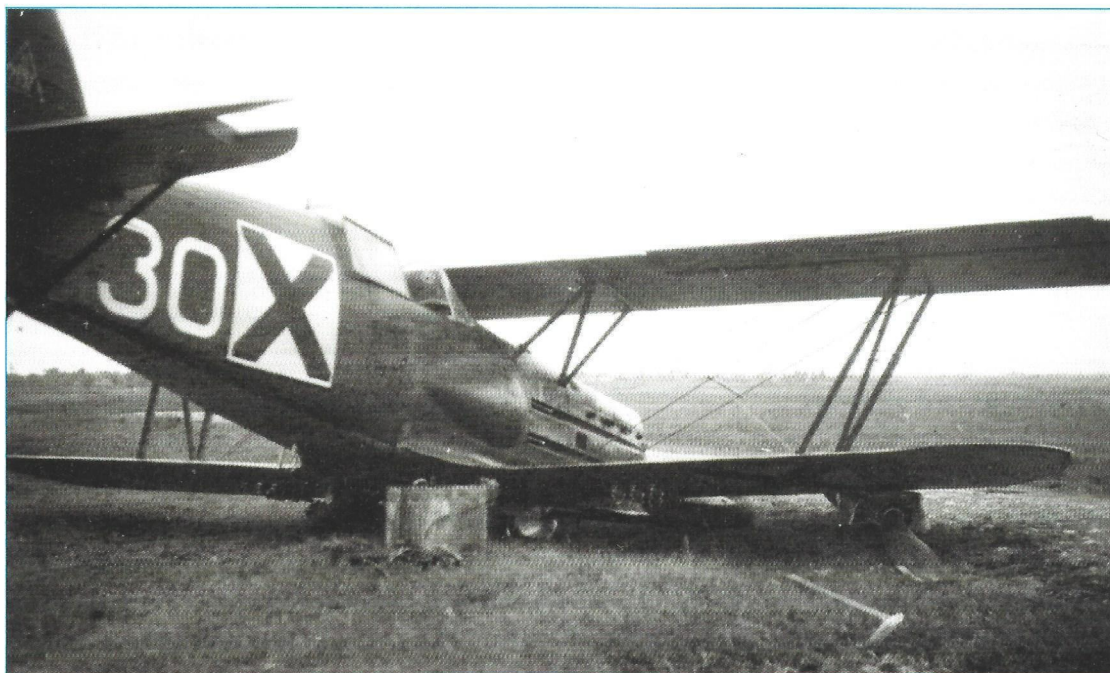
Dogan No. 30 ended up on its belly following a botched landing on Daskal-Atanasovo airfield on 13 August 1942. The pilot, Kand. podof. Tsonyu P. Uzunov of the 632nd Yato, escaped unhurt, but most probably was punished for the error he made. The aircraft does not seem to sport the tapering yellow flash along the fuselage.

On 13 August, *Kand. podof.* Tsonyu P. Uzunov of the 632nd *Yato* taxied too long after landing on Daskal-Atanasovo airfield (located about 25 km SE from Stara Zagora). The biplane, No. 30/7037, built in 1938, broke its undercarriage and ended up on its belly, which caused 25% damage to the airframe. Next day, *Dogans* of the 662nd *Yato* were performing ground attack exercises nearby Daskal-Atanasovo airfield. Bf 109E *Strelas* of 3/6. *Orlyak* provided top cover. While taking off for an air escort sortie, *Strela* No. 7/7057 flown by *Podofitser* Dako P. Dakov of the 672nd *Yato* veered off course and crashed into a parked Avia B.534 *Dogan*, No. 35. Both aircraft had to be written off following the violent collision. Also on 14 August, another accident happened at Daskal-Atanasovo, this time involving *Dogan* No. 40, with *Podofitser* Petăr Bisov of the 652nd *Yato* at the controls. Finally, an old Avia B.534 (No. 63/7037), built in 1937, was slightly damaged in a tyre accident involving *Poruchik* Hristo Pazvantov of the 632nd *Yato*. The incident happened on Marno Pole/Karlovo main air base on 11 September 1942. This was to be the last recorded accident of the year involving the Avia B.534 fighter, available to the Author.

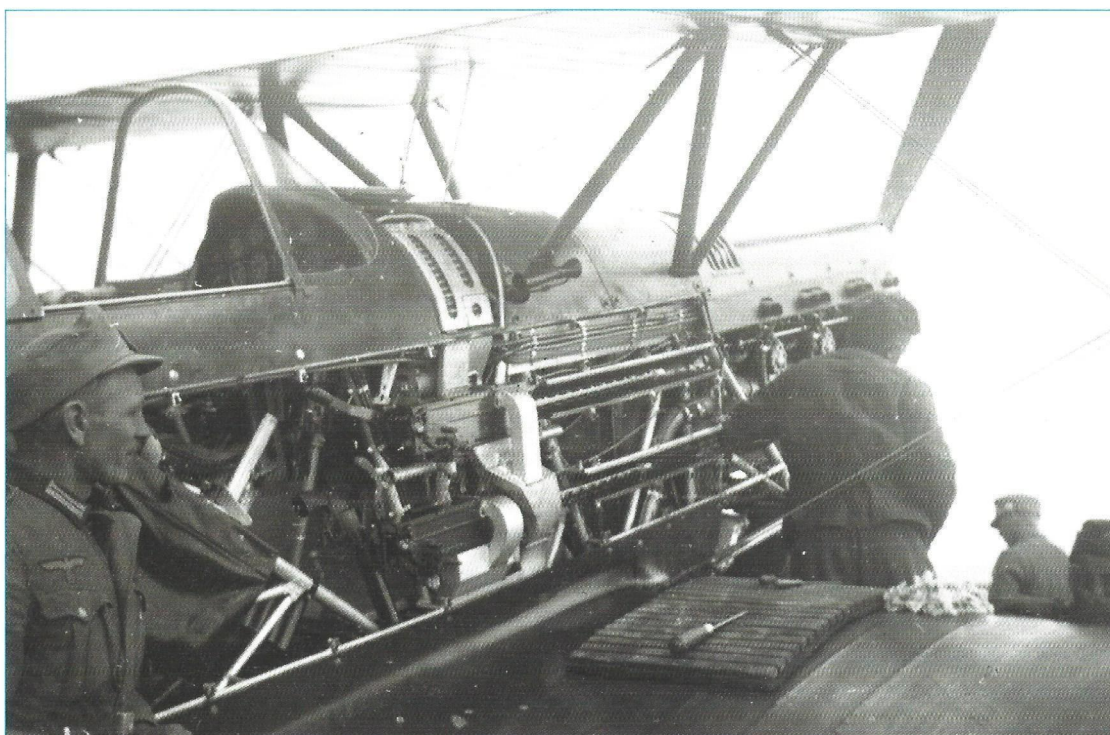
An Avia B.534 is being serviced in field conditions. At left, a German soldier watches the activity. Due to removed side panels, the on-board machine guns and various auxiliary equipment can be seen to advantage.

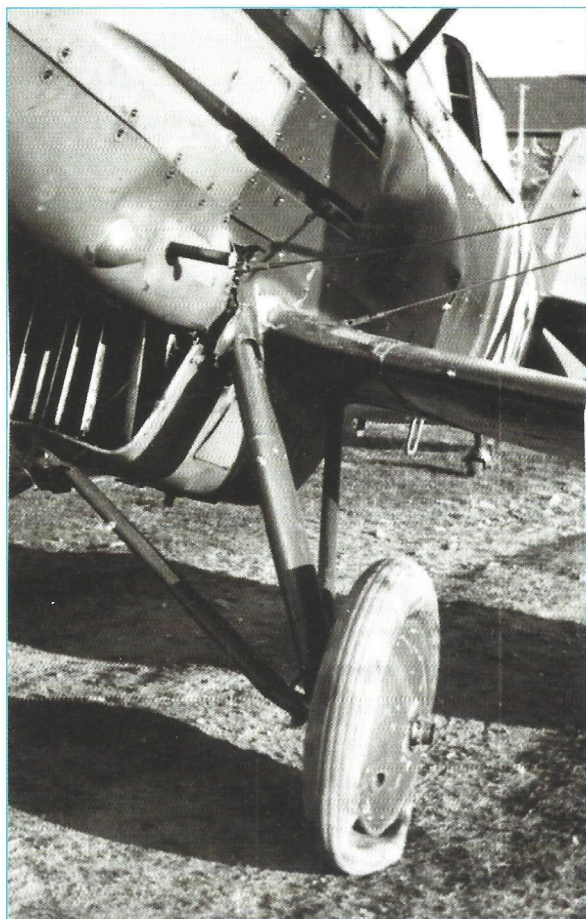
The Dunlop-model port tyre of aircraft No. 63 of the 632nd Yato was punctured during taxiing on Marno Pole/Karlovo main air base, on 11 September 1942. Notice the yellow painted upper wingtips; however, the elevators don't appear to have received the same paintjob. The close-up photo shows the yellow painted nose and rudder, as well as the mid-fuselage band. Stara Planina Mountain range offers a majestic background décor.

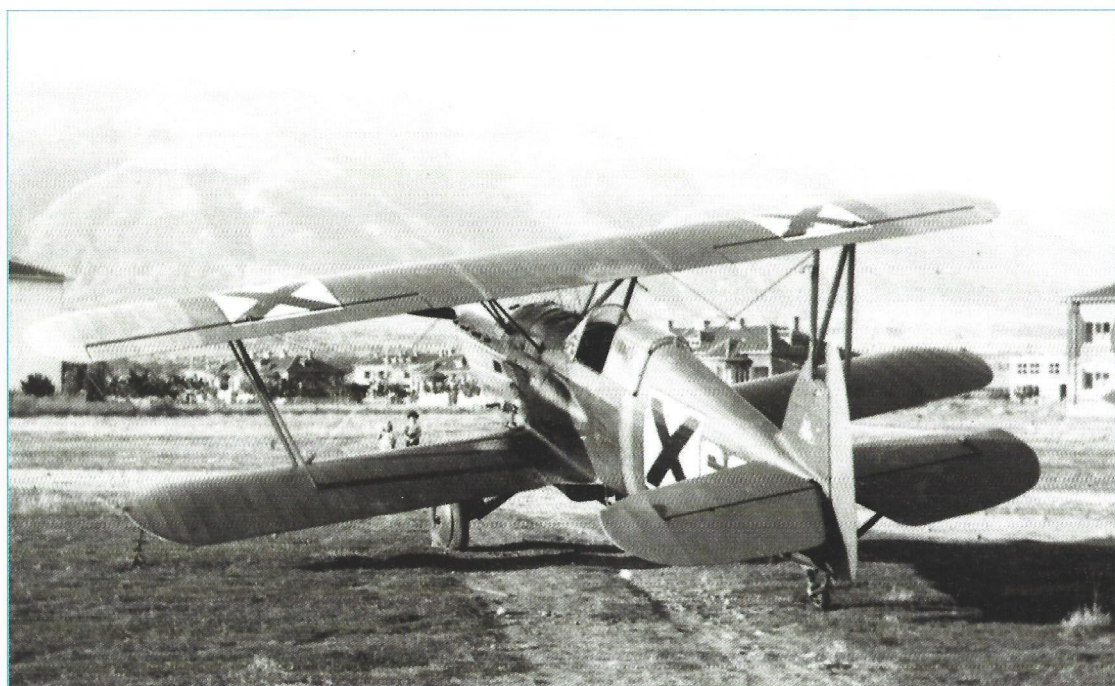
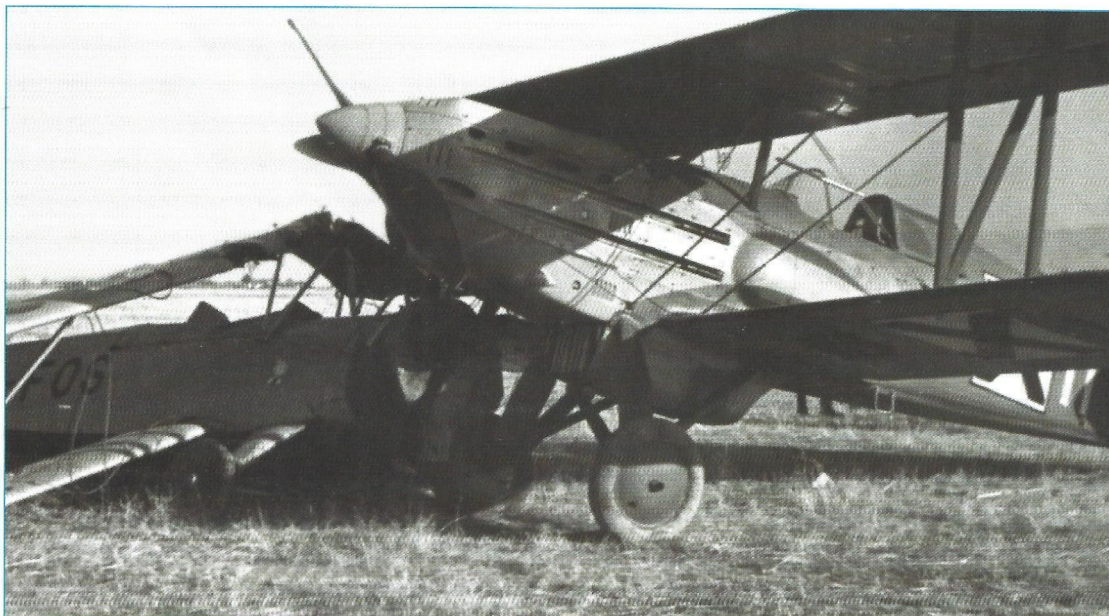
Post-accident photo documenting the collision between an Avia B.534 Dogan, No. 11, and a Fw 44J Vrabche, LZ-FOS, NN 18/7021. This incident happened on 23 August 1943, when Ppor. Stefan Marinopolski ran over two parked Vrabche, LZ-FOY and LZ-FOS, while landing on Sofia (Vrazhdebna) airfield. Of special interest is the emblem painted on the front area of the trainer's fuselage. Such emblems were seen very rarely on Bulgarian aircraft.

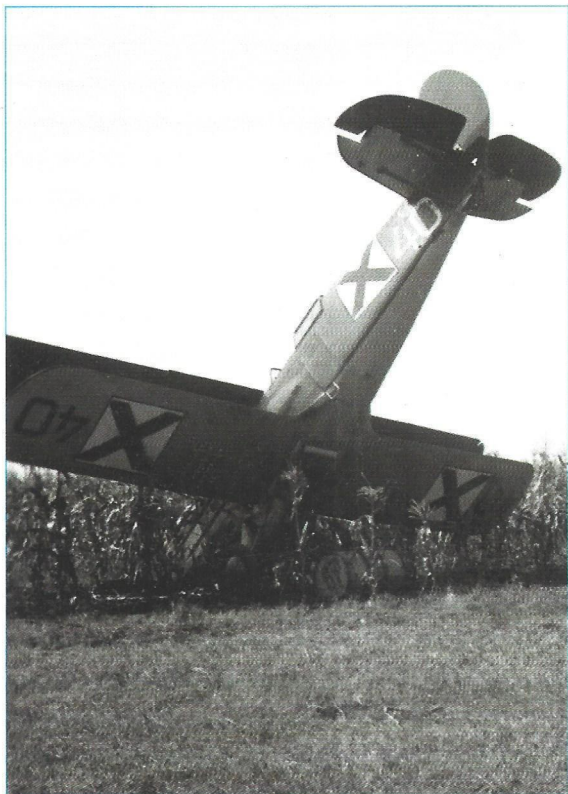
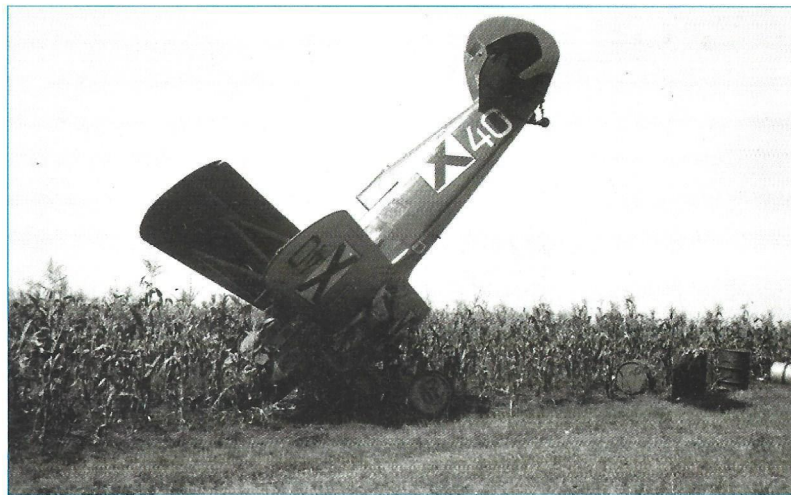
Dogan No. 40 ended up 'sampling' corn following an overly long taxiing on Daskal-Atanasovo airfield. At the edge of the maize field, the aircraft tripped on a fuel barrel (notice the number 87 painted on it, most probably identifying the fuel octane) and nosed in. The incident, involving Podofitser Petăr Bisov of the 652nd Yato, happened on 14 August 1942, and ended up with only minor damage to the airframe. The view revealing the bottom of the aircraft shows that both elevators and the rudder were painted yellow, and the serial number was repeated on the lower wingtips, in black. The rearward tapering yellow flash, ending in line with the rear cockpit window, is faintly visible on the fuselage side. Notice the glossy finish of the camouflage top covering lacquer, as well as the national markings.

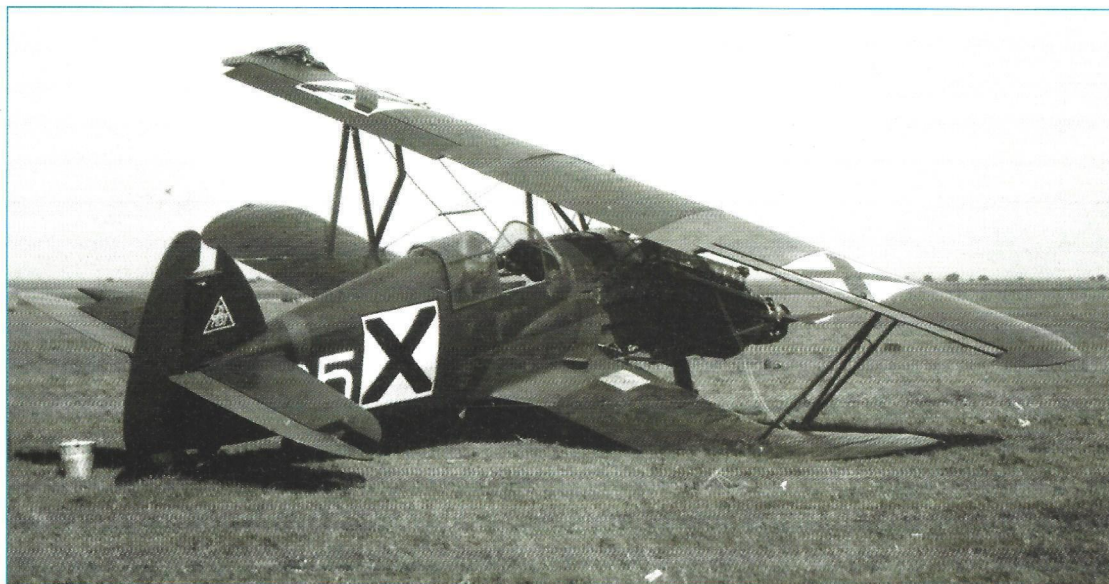
Compared to the other accidents from 1942, illustrated by photos, this one appears to be the most serious. Dogan No. 35 was damaged when Bf 109E Strela No. 7/7057, flown by Podofitser Dako P. Dakov of the 672nd Yato, veered off course and crashed into it. As a consequence, the engine tore off its mount, the lower starboard wing and upper port wing were damaged, the undercarriage broke off. Both aircraft had to be written off following the violent collision. Apparently, the airframe had been repainted in places (like the outer part of the upper starboard wing, the lower fuselage area underneath and in front of the cockpit, as well as the lower starboard wing root) with a lighter shade colour, probably mid-green, covering earlier repairs.

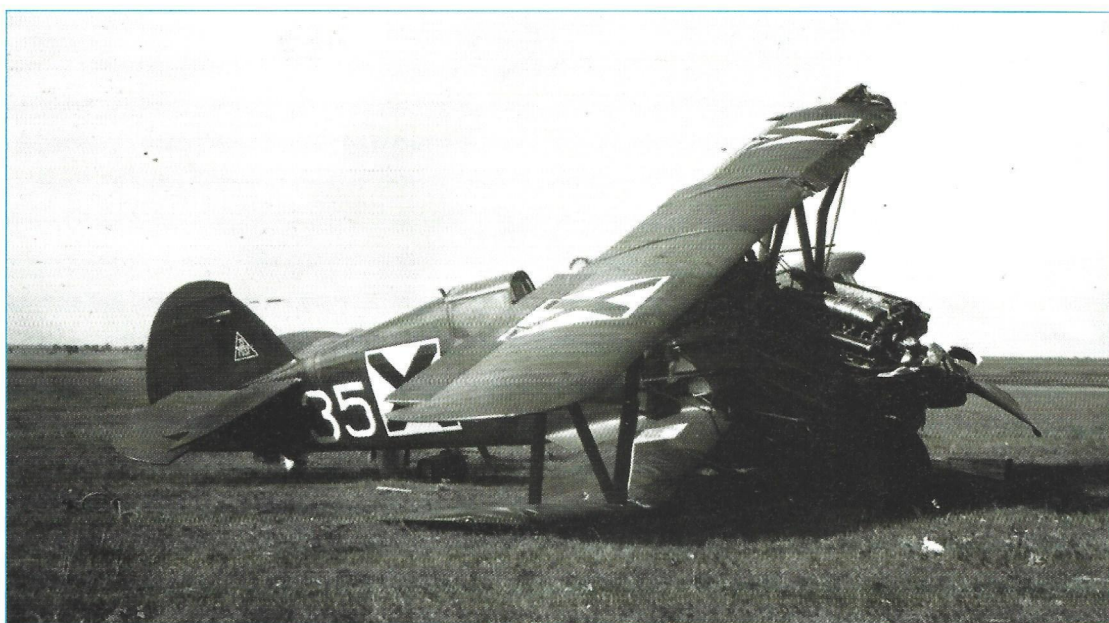
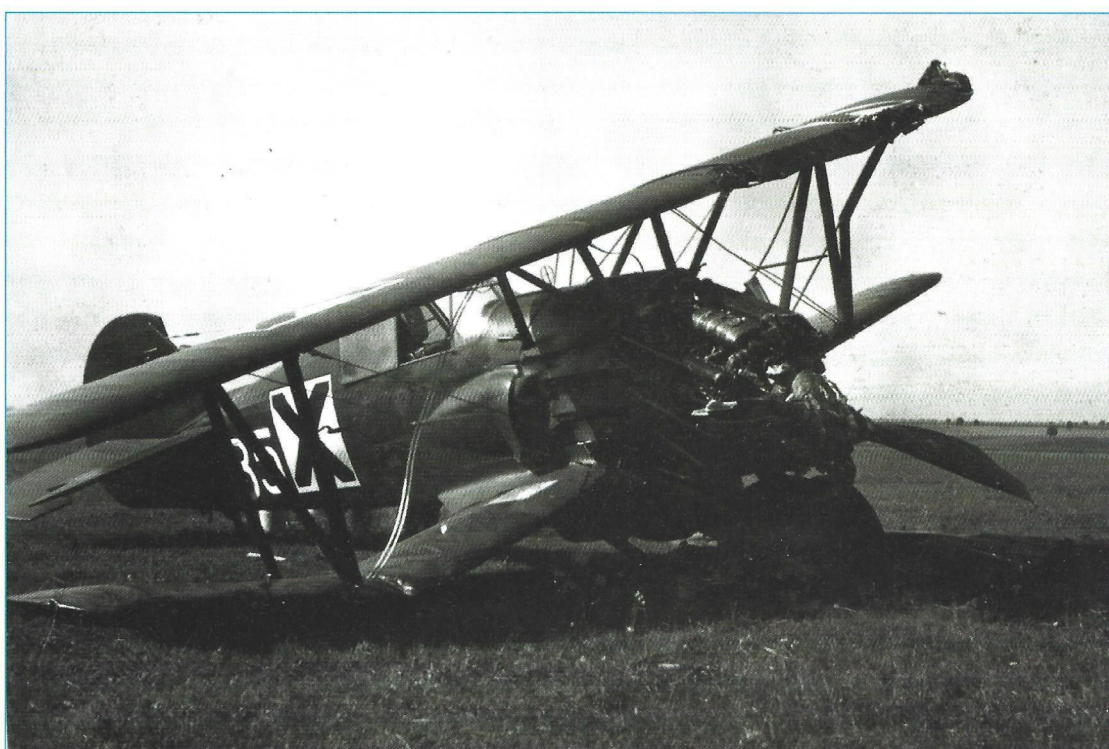
While taking off from Marno Pole on 15 June, the engine of *Dogan* No. 44/7037 quit, compelling the pilot, *Zam.* of. Mihail T. Uzunov of the 632nd *Yato*, to belly land his powerless mount, causing 40% damage. Thanks to the different type of black/white negative film, the yellow is shown prominently in these photos. This allows the onlooker to identify the area painted in yellow: engine cowlings, rearward tapering fuselage flash, rudder and elevators. This was one of the rare occasions when the aircraft's original construction number (425) was displayed on the fin.

at low altitude. Precisely one month later, on the 13th, it was the turn of a 662nd Yato pilot, *Zamestnik ofitser* (Warrant Officer)³⁰ Toni E. Tonev to suffer an accident at Marno Pole main air base, albeit a much lighter one. While landing, the *Dogan* No. 70/7037 ended up on its nose (15% damage). A similar accident involved *Dogan* No. 50/7037, which also ended up on its nose following a botched taxiing, also at Karlovo, on 20 April. The pilot, *Kandidat podofitser* Stefan D. Petrov of the 642nd Yato, escaped unhurt. On 29 May, the undercarriage leg and the lower starboard wing of *Dogan* No. 71/7037 were broken off during a bad landing at Marno Pole air base by *Kand. podof.* Georgi N. Atanasov of the 662nd Yato. While taking off, also from Marno Pole on 15 June, the engine of *Dogan* No. 44/7037 (c/n 425) lost power,

compelling the pilot, *Zamestnik ofitser* Mihail T. Uzunov of the 632nd *Yato*, to belly land his unpowered mount, causing 40% damage.

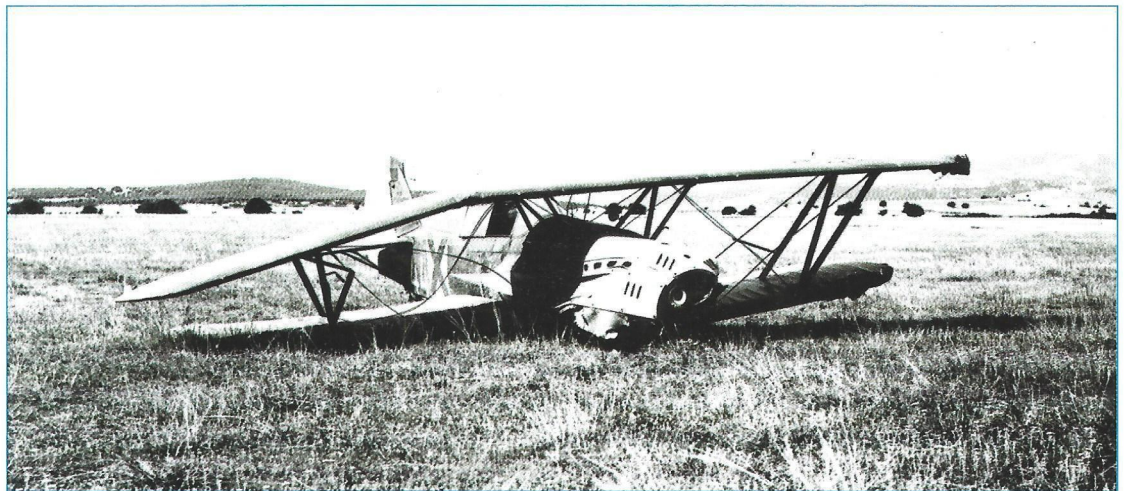
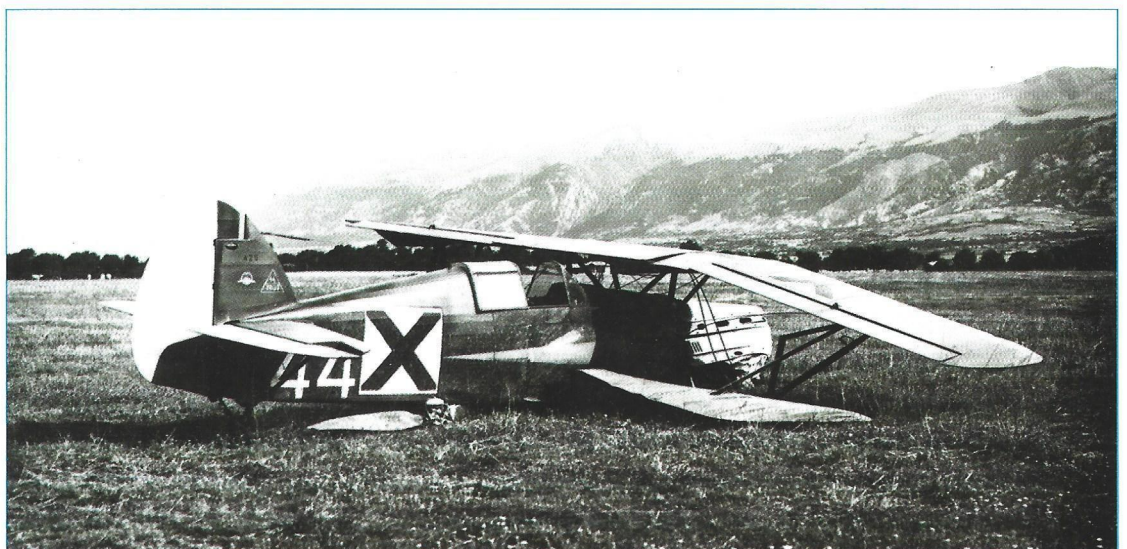
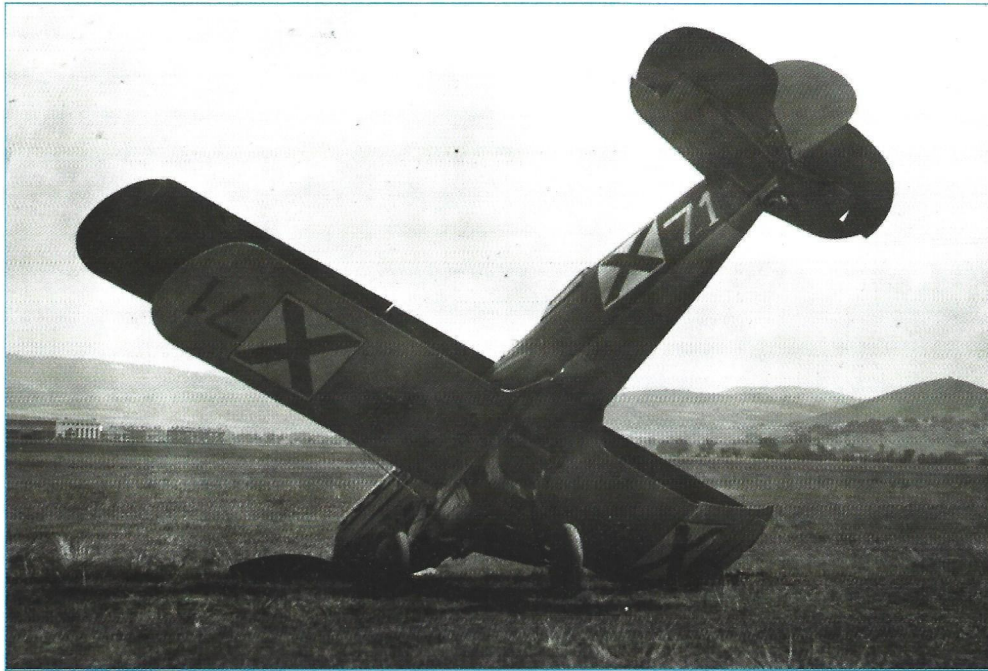
Most post-accident photos documenting taxiing incidents look pretty much the same: broken undercarriage leg, lower wing and propeller. This series of photos, depicting Dogan No. 71/7037, is no different. On 29 May 1942, Kand. podof. Georgi N. Atanasov of the 662nd Yato performed a bad landing on Marno Pole air base, slightly damaging his mount.

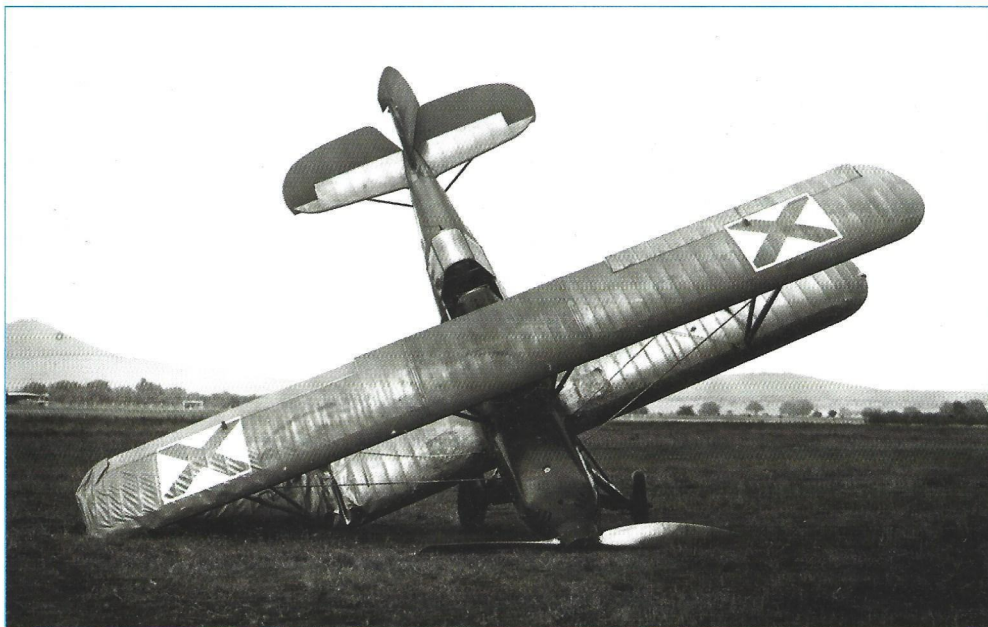
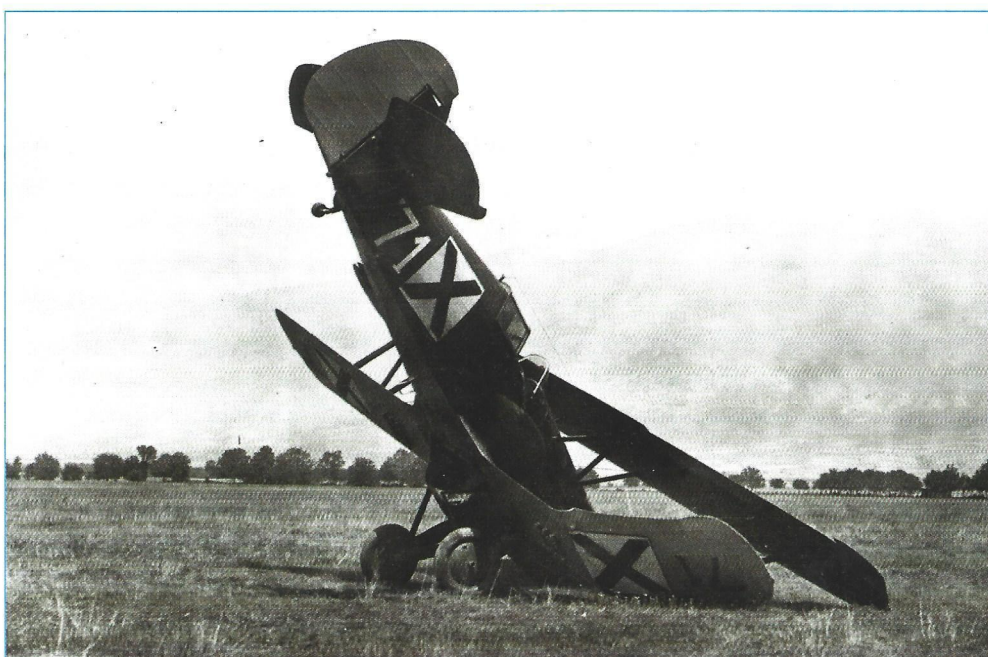
Another series of photos depicting the usual accident scene, with the exception that the undercarriage appears to be unbroken. This 'pilot's monument' – as such incidents, when the aircraft ended up on its nose, were informally called by airmen all over the world – was performed by 662nd Yato pilot, Zamestnik ofitser (Warrant Officer) Toni E. Tonev, at Marno Pole main air base, on 13 April 1942. The damage inflicted to the airframe of aircraft No. 70/7037 was minor, officially assessed at 15%. The shiny, glittering undersurface colour gives the strong impression of silver finish, which was the most common occurrence. Curiously, the lower struts of the horizontal stabiliser appear to be painted half silver, half khaki, possibly testimony of repaint after a previous accident.

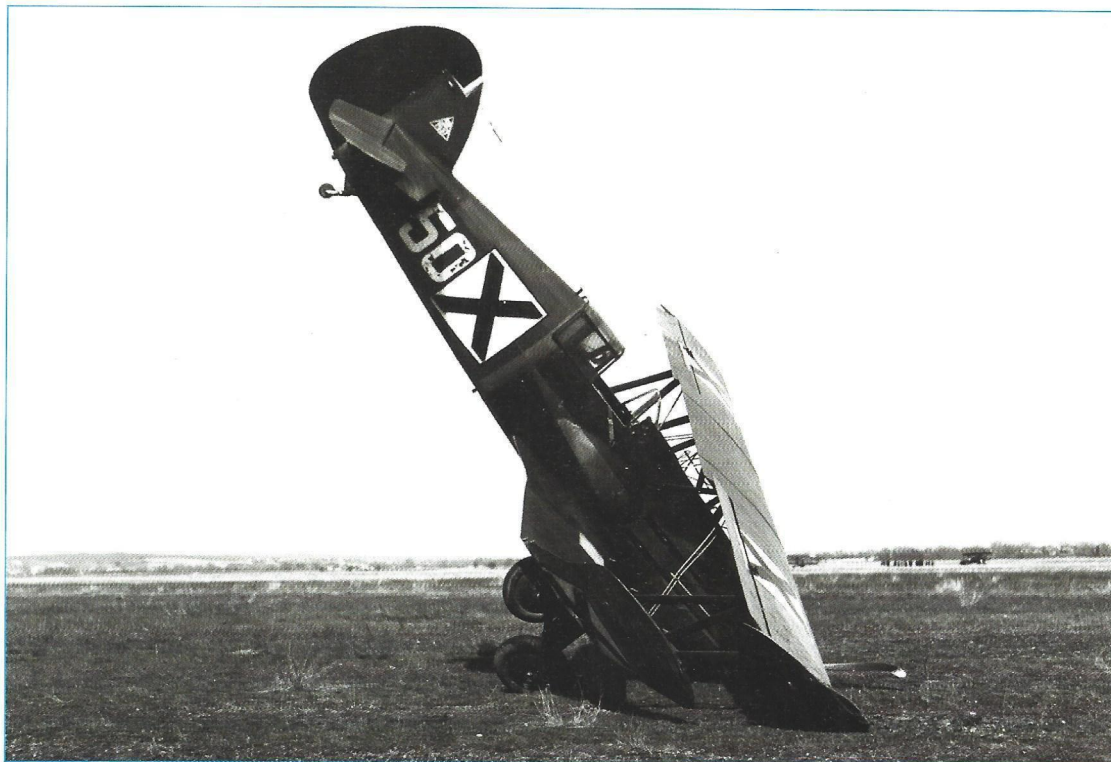
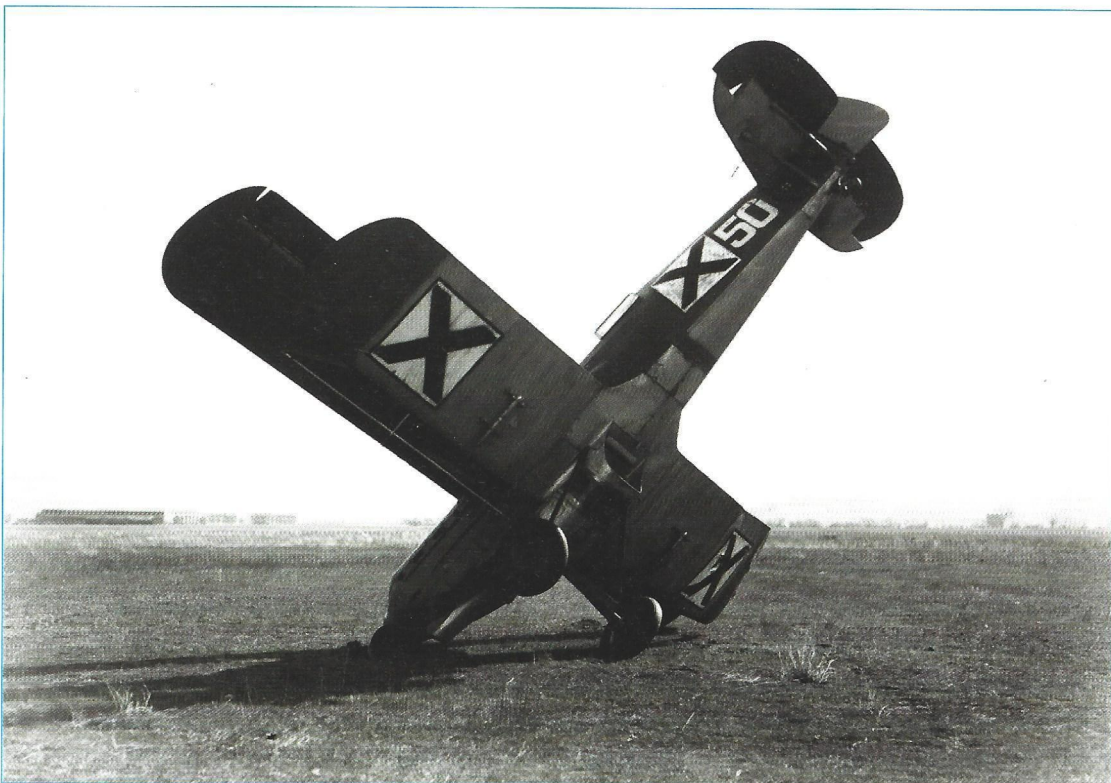
This time, both the upper and the bottom wingtips were painted yellow, as were the rudder and the elevators.

A yellow mid-fuselage band and a rearward tapering flash were applied as well. The aircraft's serial number was not shown on the outer lower wingtips (or was overpainted with yellow). Based on the shininess of the undersurface finish, the area appears to be covered with silver paint. Interestingly, only one bomb rack was attached to each lower wing. Another Dogan in the background, at right, taxies at high speed, as on Marno Pole it was business as usual.

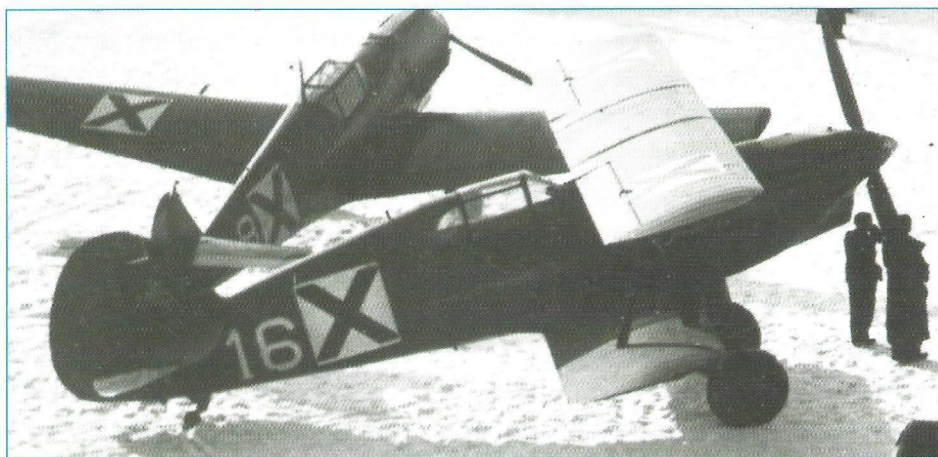
Curiously, on the port wing
undersurface number 2 can
be seen; however, on the
rear fuselage the bottom
part of number 1 is visible.

Replacement wing could
be a plausible answer. The
removable U-shape bottom
panel of the engine cowling
is a replacement part, and
it's painted either in light
grey camouflage colour, or
wears only a coat of primer,
also grey.

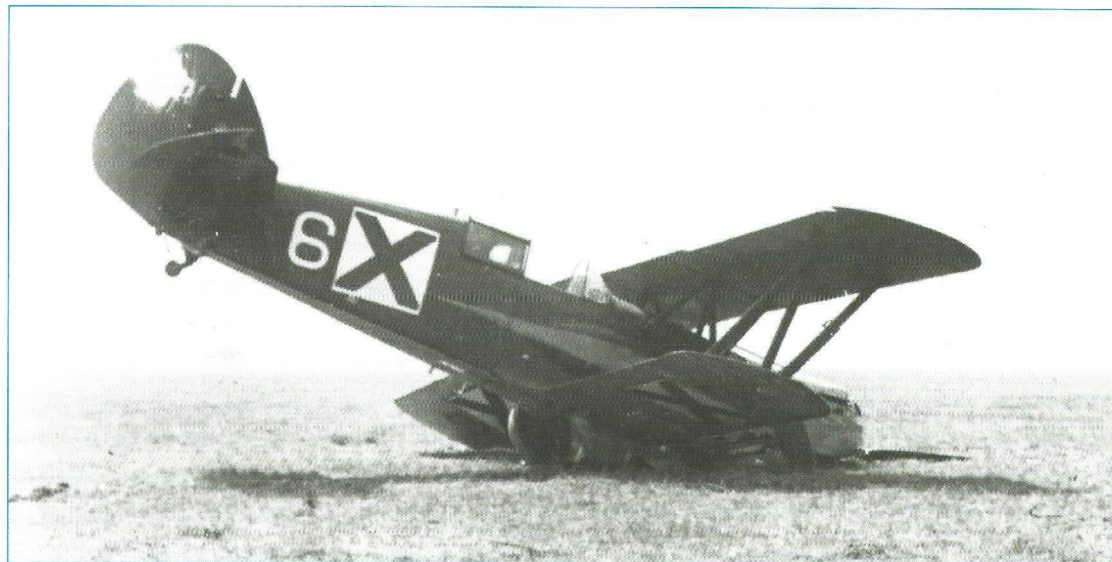
This faded post-accident scene photo shows Dogan No. 6/7037 after it crashed due to the overly low landing speed while approaching Dolna Mitropoliya landing ground on 19 April 1943. The pilot, Podofitser Dimităr A. Dimitrov of the Piloting School, escaped unhurt – except for a hefty scare. The airframe, however, suffered extensive damage, evaluated at 50%. The numeral looks like an inverted 9. The light area on the rudder is a defect on the scanned print.

Earlier that year, several accidents happened to *Dogan* pilots, none of them fatal. On 19 April, *Ppor.* Dimităr A. Dimitrov of the Piloting School performed a bad landing on Dolna Mitropoliya; the bi-plane bounced from the ground then fell from three metres. As a result of the botched landing, the undercarriage of *Dogan* No. 6/7037 broke off, the airframe suffered 50% damage, and undoubtedly the rookie pilot was reprimanded (see photo on page 190). The next incident happened only two days later, this time at Bozhurishte. While landing, the engine of *Dogan* No. 26/7037 suddenly quit. Luckily, the pilot, *Podof.* Kiril I. Kălvachev³⁷, could land safely his mount. Following the investigation, it turned out that the petrol was of bad quality, that's why the engine stopped. Also in April, on the 27th, *Podof.* Yordan Daskalov³⁸ damaged lightly his mount, *Dogan* No. 5/7037, rolling onto railway tracks during landing on Sofia airfield. In the summer, on 23 August, *Ppor.* Stefan Marinopolski collided with two *Vrabche* (code name for the Focke-Wulf Fw 44J trainer), LZ-FOY and LZ-FOS, while landing with *Dogan* No. 11/7037 also on Sofia airfield (see photo on page 177). All three aircraft were damaged. In his logbook, Marinopolski briefly mentioned only *zlopoluka*, i.e. accident. There are no more accidents recorded in the author's files, nevertheless further incidents certainly happened.

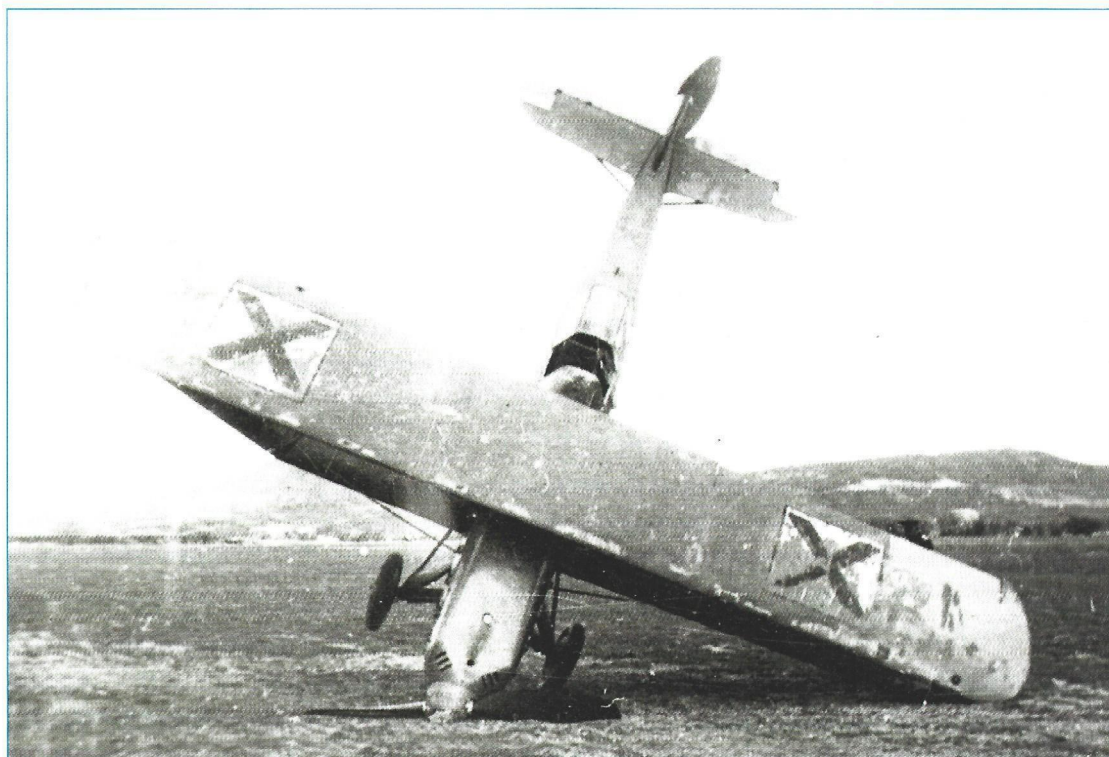
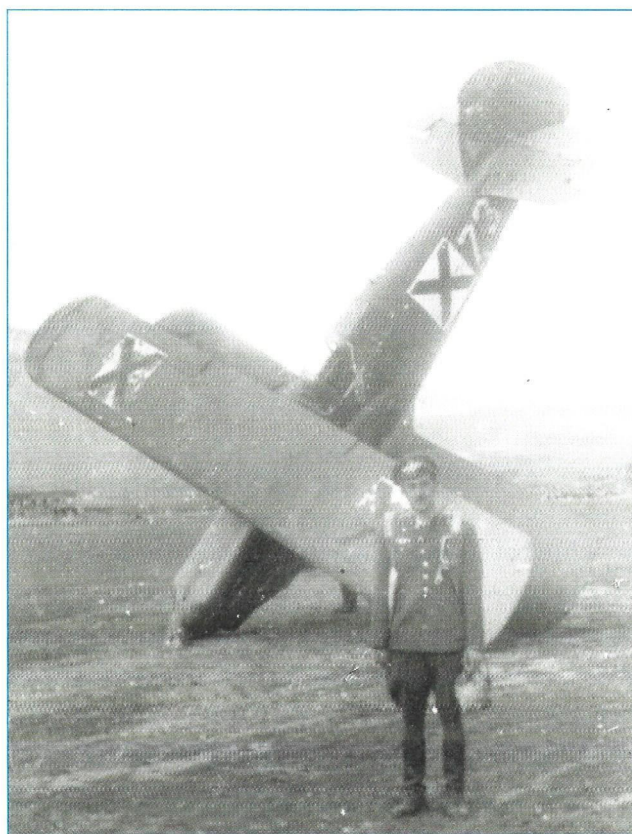
Landing with the Avia B.534 was tricky, due to its narrow undercarriage. This design shortcoming led to numerous taxiing accidents, which usually caused minor damage to the wings and propeller. Details of the depicted accident involving Dogan No. 73 are unknown; nevertheless, it is believed that it happened sometime in 1943, which may explain the extremely worn appearance. This particular aircraft was officially written off on 28 June 1944; however, it is unlikely that this minor landing accident was the cause of its demise. Most likely, it was destroyed during the devastating USAAF raid against Karlovo air base. Notice the

faded yellow upper wingtips (as well as the barely seen yellow elevators) and chipped national marking. This pair of photos could be a prime source for the seasoned modeller, who wishes to depict his/her model kit wearing heavily weathered and thoroughly chipped paintjob.

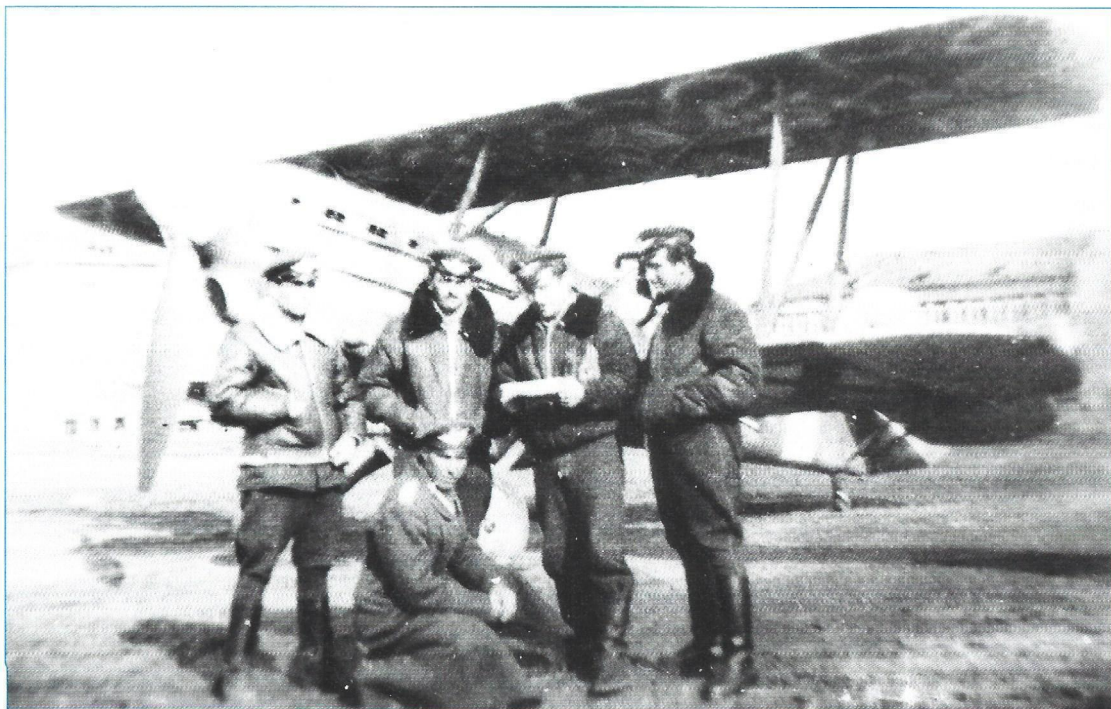
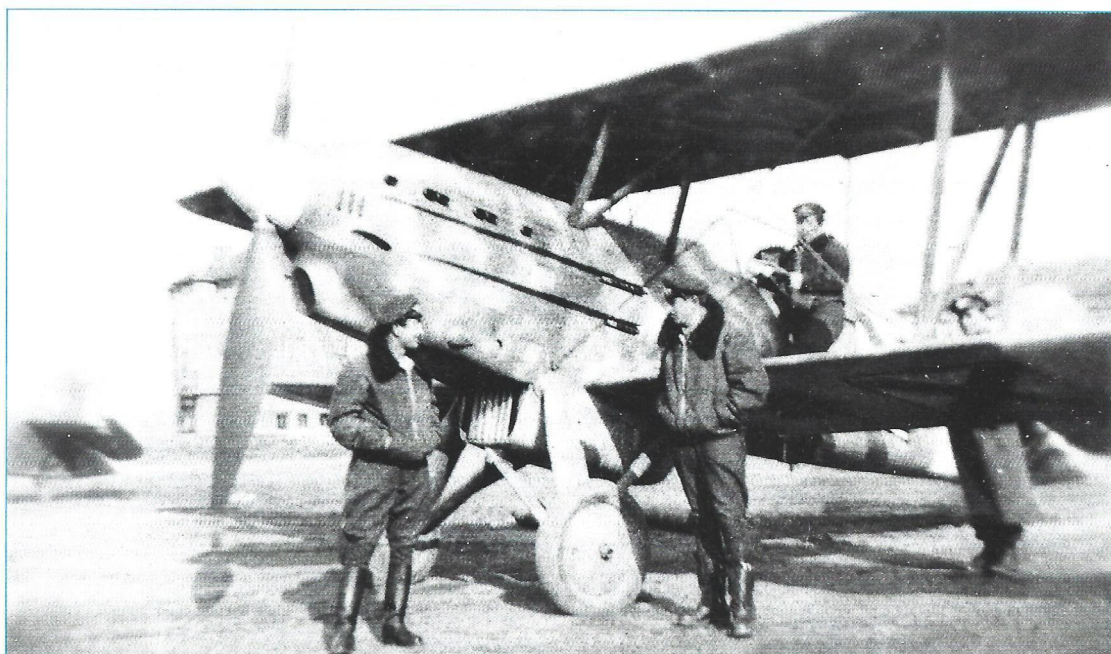
This Avia B.534 of 2/2. Shturmovi Orlyak was photographed on Vrazhdebna airfield, in late 1944. The camouflaged lower surface of the upper wing is well visible despite the indifferent quality of the prints.

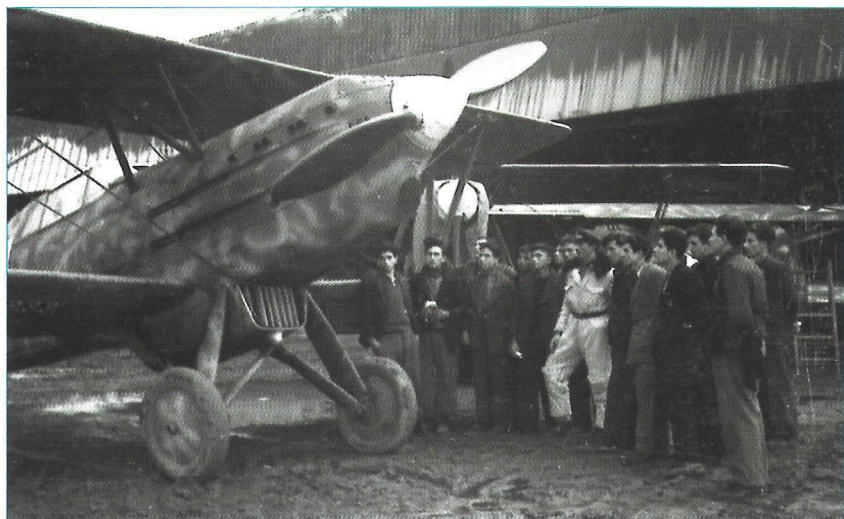
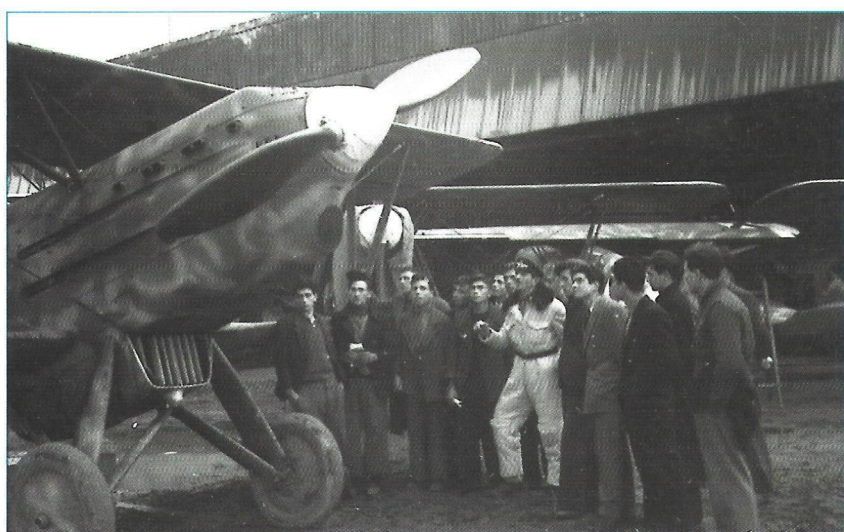
A pilot of 2/2. Shturmovi Orlyak presents one of the squadron's Dogans to young civilian men, during an 'open day' event at Vrazhdebna airfield, on a muddy winter day in late 1944/early 1945.

One can observe that the entire engine cowling was painted wraparound in dark green, with light grey squiggles expanding until the bottom. The lower surface of the upper wing was painted in a similar fashion as well (details often left unnoticed by various profile artists and model kit makers). In the background, the camouflage pattern of another Dogan also finished in the so-called 'assault camouflage scheme' can be studied.

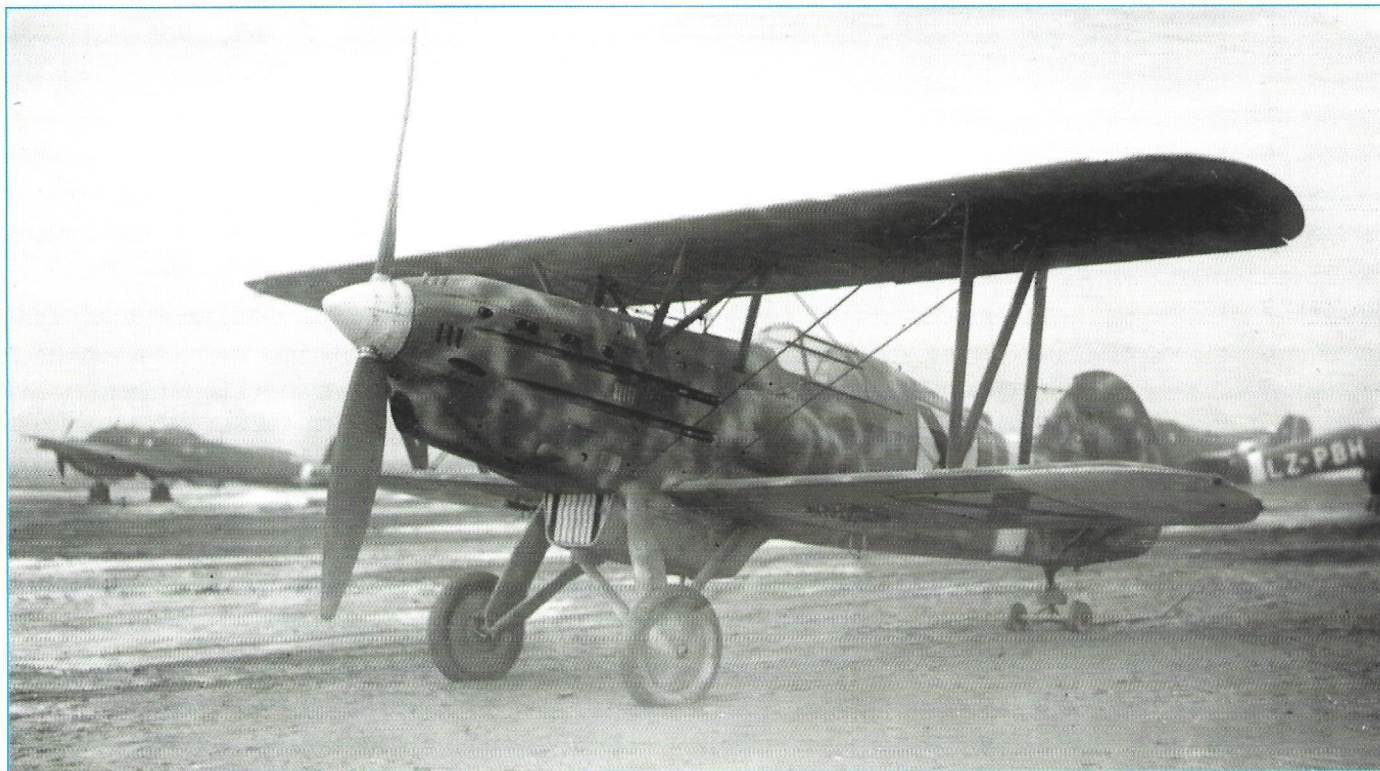
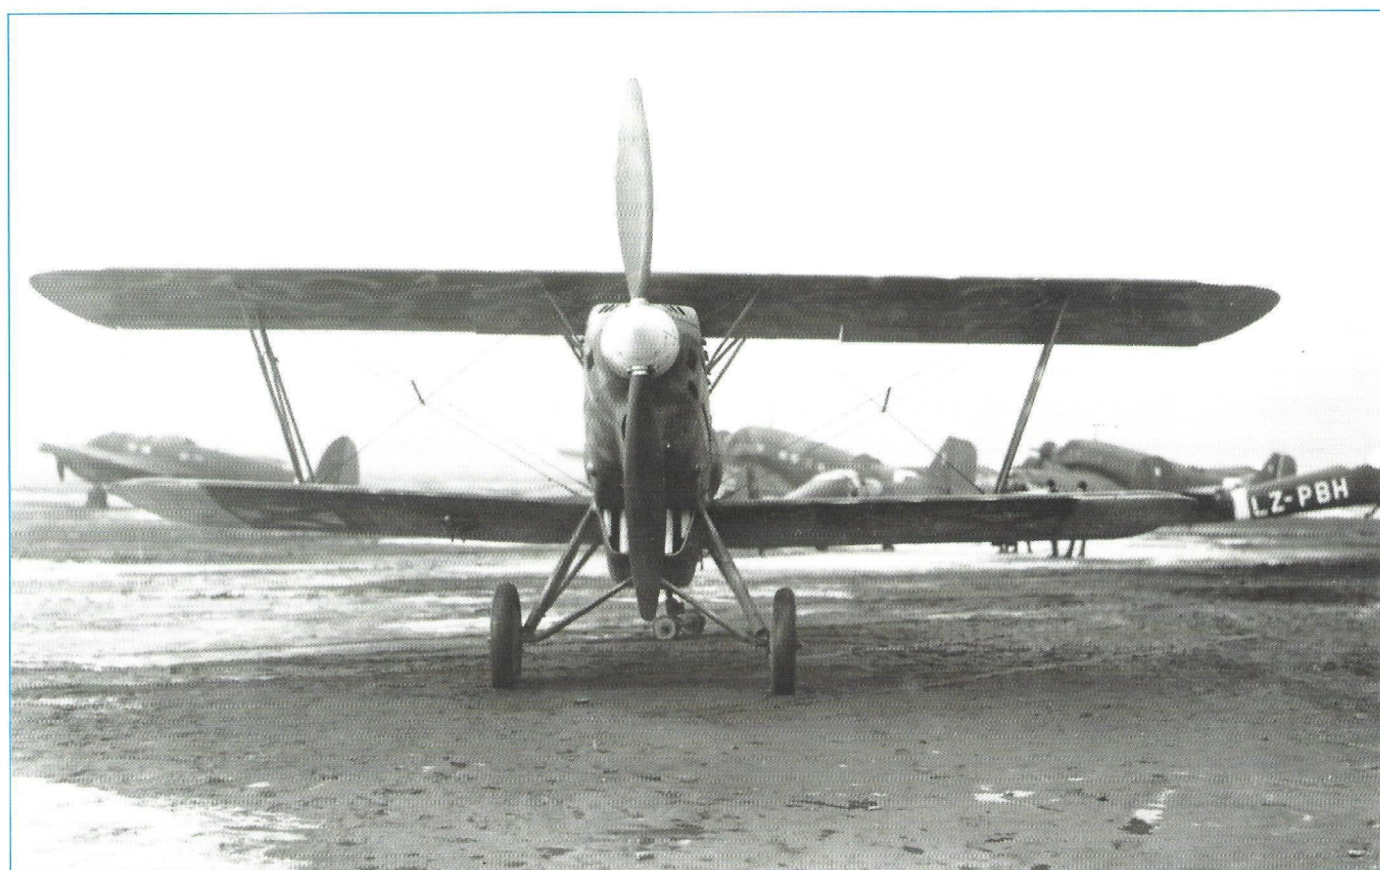
For some reason, the Avia B.534s of 2/2. Shturmovi Orlyak did not wear large size serial numbers on their rear fuselage, as they did while on duty as interceptor fighter and trainer. The ID of the aircraft could be determined only by the small size serial number written in the upper part of the white triangle usually applied on mid-fin. This detail makes difficult to identify a certain aircraft depicted in a not perfect shot. Luckily, a high-resolution photo taken from 7 o'clock of the same aircraft (see master photo of the colour profile on page 210) reveals the identity of this Dogan: 31/7037. At the time anti-German hostilities begun, this particular aircraft was not among the nine serviceable Dogans with the 2/2. Shturmovi Orlyak; therefore, it must have arrived in the group later on, probably in early November, when the number of available aircraft increased from a meagre three to six. Curiously, the tail wheel is replaced by a rudimentary two-wheel cart with a handle that assisted moving the aircraft around. At right, a civilian registered Focke-Wulf Fw 58 Gäläb (Гълѣбъ), LZ-PBH (No. 8 on tail), is visible, behind the Avia's rudder a Junkers Ju 52/3m Sova is depicted, while at left, the sole Heinkel He 111H-16, LZ-XAC, VIP transport can be seen. The front view reveals two more aircraft in the background, a Bücker Bü 181 'Bestmann' and another Ju 52/3m Sova, probably No. 5 (LZ-UNM).
